# Ecological Implications Assessment

**Site:** Argoed High School, Mynydd Isa Campus, Bryn Road, Bryn Y Baal,  
Mold, Flintshire, CH7 6RY

**Ref:** 20178/E4

**Client:** WEPCo Limited

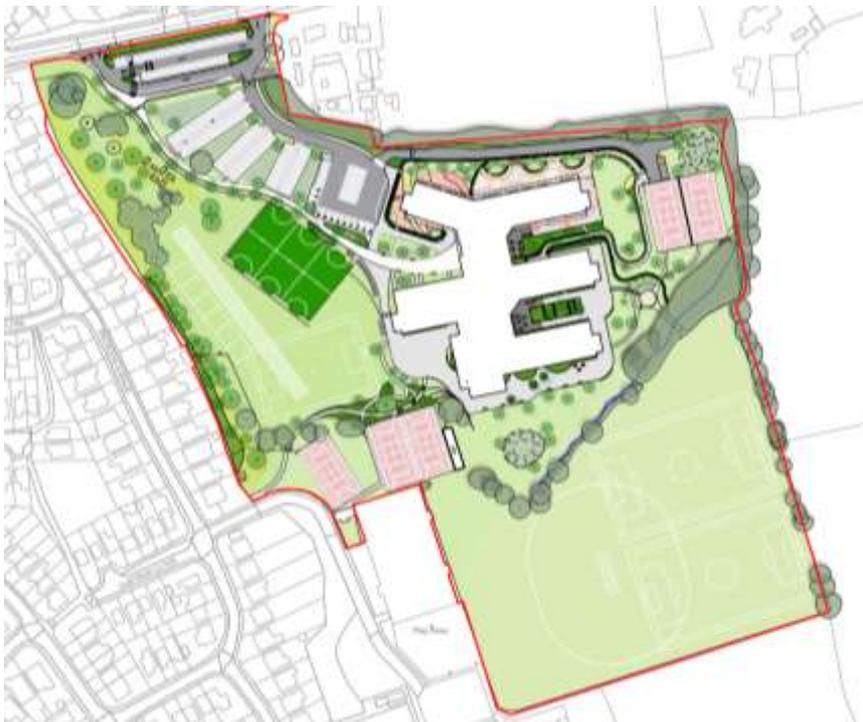
**Plan 1 Proposed site layout**

The application will seek permission for the redevelopment of the Argoed High School site to develop a new primary and secondary school in a co-located building, to be known collectively as the Mynydd Isa Campus. In summary, it is understood that the proposed works will include the:

A proposed site layout for the development is shown below (Plan 1).

The proposed landscaping scheme will provide suitable for nesting and foraging birds, small mammals and pollinating insects.

The applicant has confirmed that replacement trees and new additional tree planting is proposed, to the sum of 131no. trees. All existing mature trees and hedgerows along the application site boundaries would be retained, with additional tree, hedge and shrub planting proposed around the main school building in accordance with the Planting Strategy, which is submitted with the planning application. The existing school playing fields to the south of the site would remain as existing. An area to the northwest of the site and west of the proposed car park is proposed to be landscaped with meadow seeded areas and tree planting for educational use as a forest school.

The areas of planting close to the building would function as rain gardens to capture treat and convey water from the roof that would connect to a site wide SUDS network comprising swales to parking areas and ponds at the east of the site.

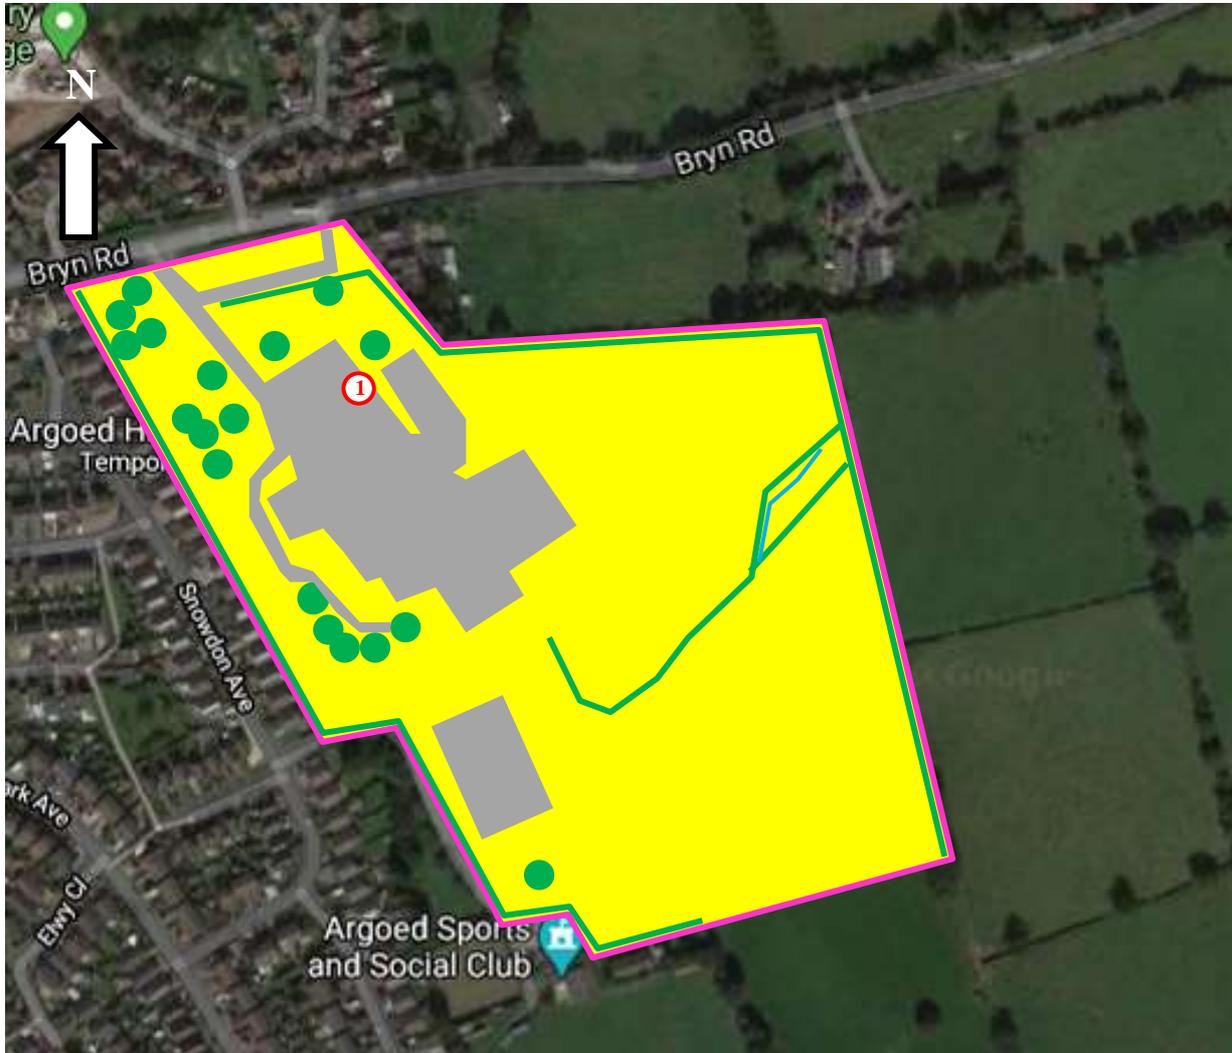
### Appendix 1: Phase 1 Habitat Survey Map

The site encompassed the buildings and grounds of Argoed High School.

The grounds were dominated by large playing fields sport pitches/courts and amenity grassland lawns.

Secondary habitats included a number of mixed scattered trees, sections of intact hedge and hedge with trees and a narrow, culverted brook.

An external inspection of the buildings revealed one of the buildings had medium suitability for roosting and/or hibernating bats.

Target Note 1: External gaps on building – medium suitability for bat roosting.

As such, two nocturnal surveys were undertaken, these on the evening of 22<sup>nd</sup> August and the morning of 6<sup>th</sup> September 2020.

During the evening survey no bats emerged from the school building, but two Common Pipistrelle Bats *Pipistrellus pipistrellus* were detected foraging along the perimeter hedgerow. No bats were recorded during the dawn return survey. The surveys confirmed the absence of a bat roost, and the site itself had low value to foraging bats.
